Meadow Lake Lake Management Report July 2018

# LAKEPRO, INC.

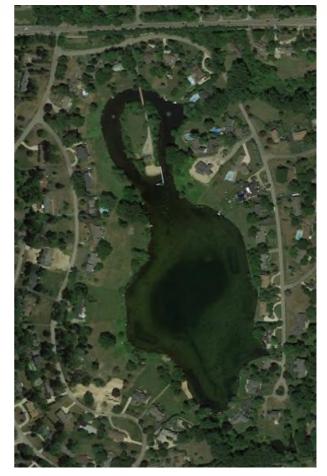
The following aerial photograph shows the locations of the sampling sites.
